Service Bulletin: 04302008 (Mandatory)

Subject: Inspection of weld on keyed style motor mounted pitch shaft end.

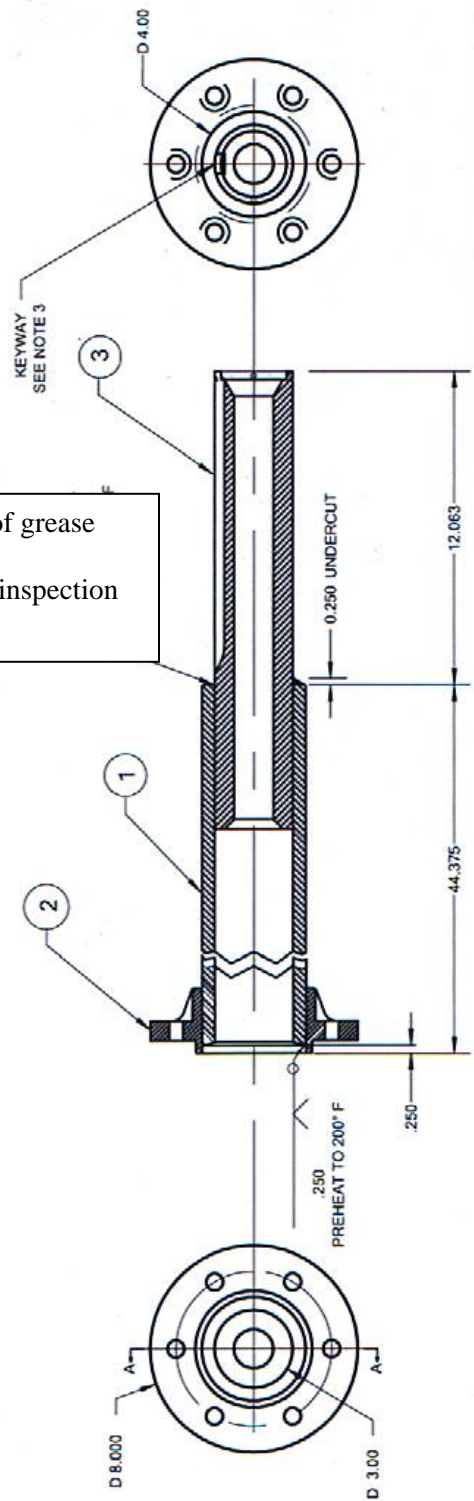
It has come to our attention that the weld holding the keyed output shaft stub onto the main pitch shaft, motor side, may have crack/s develop after years of use.

Clean the entire weld area of grease etc.
Perform the dye-penetrant inspection of entire weld.

All users of keyed pitch motor shafts are required to perform this inspection. If you note any defects, repairs are not authorized. If defect is noted replacement of shaft is the only repair authorized. Contact MaxFlight, Technical Support at 1-732-2007 ext 222 or 254 to order a replacement. Purchase orders can be sent to 1-732-281-2009, attention Carol.
